# 2002 Annual Compliance Report

## Lowman, Idaho, Disposal Site

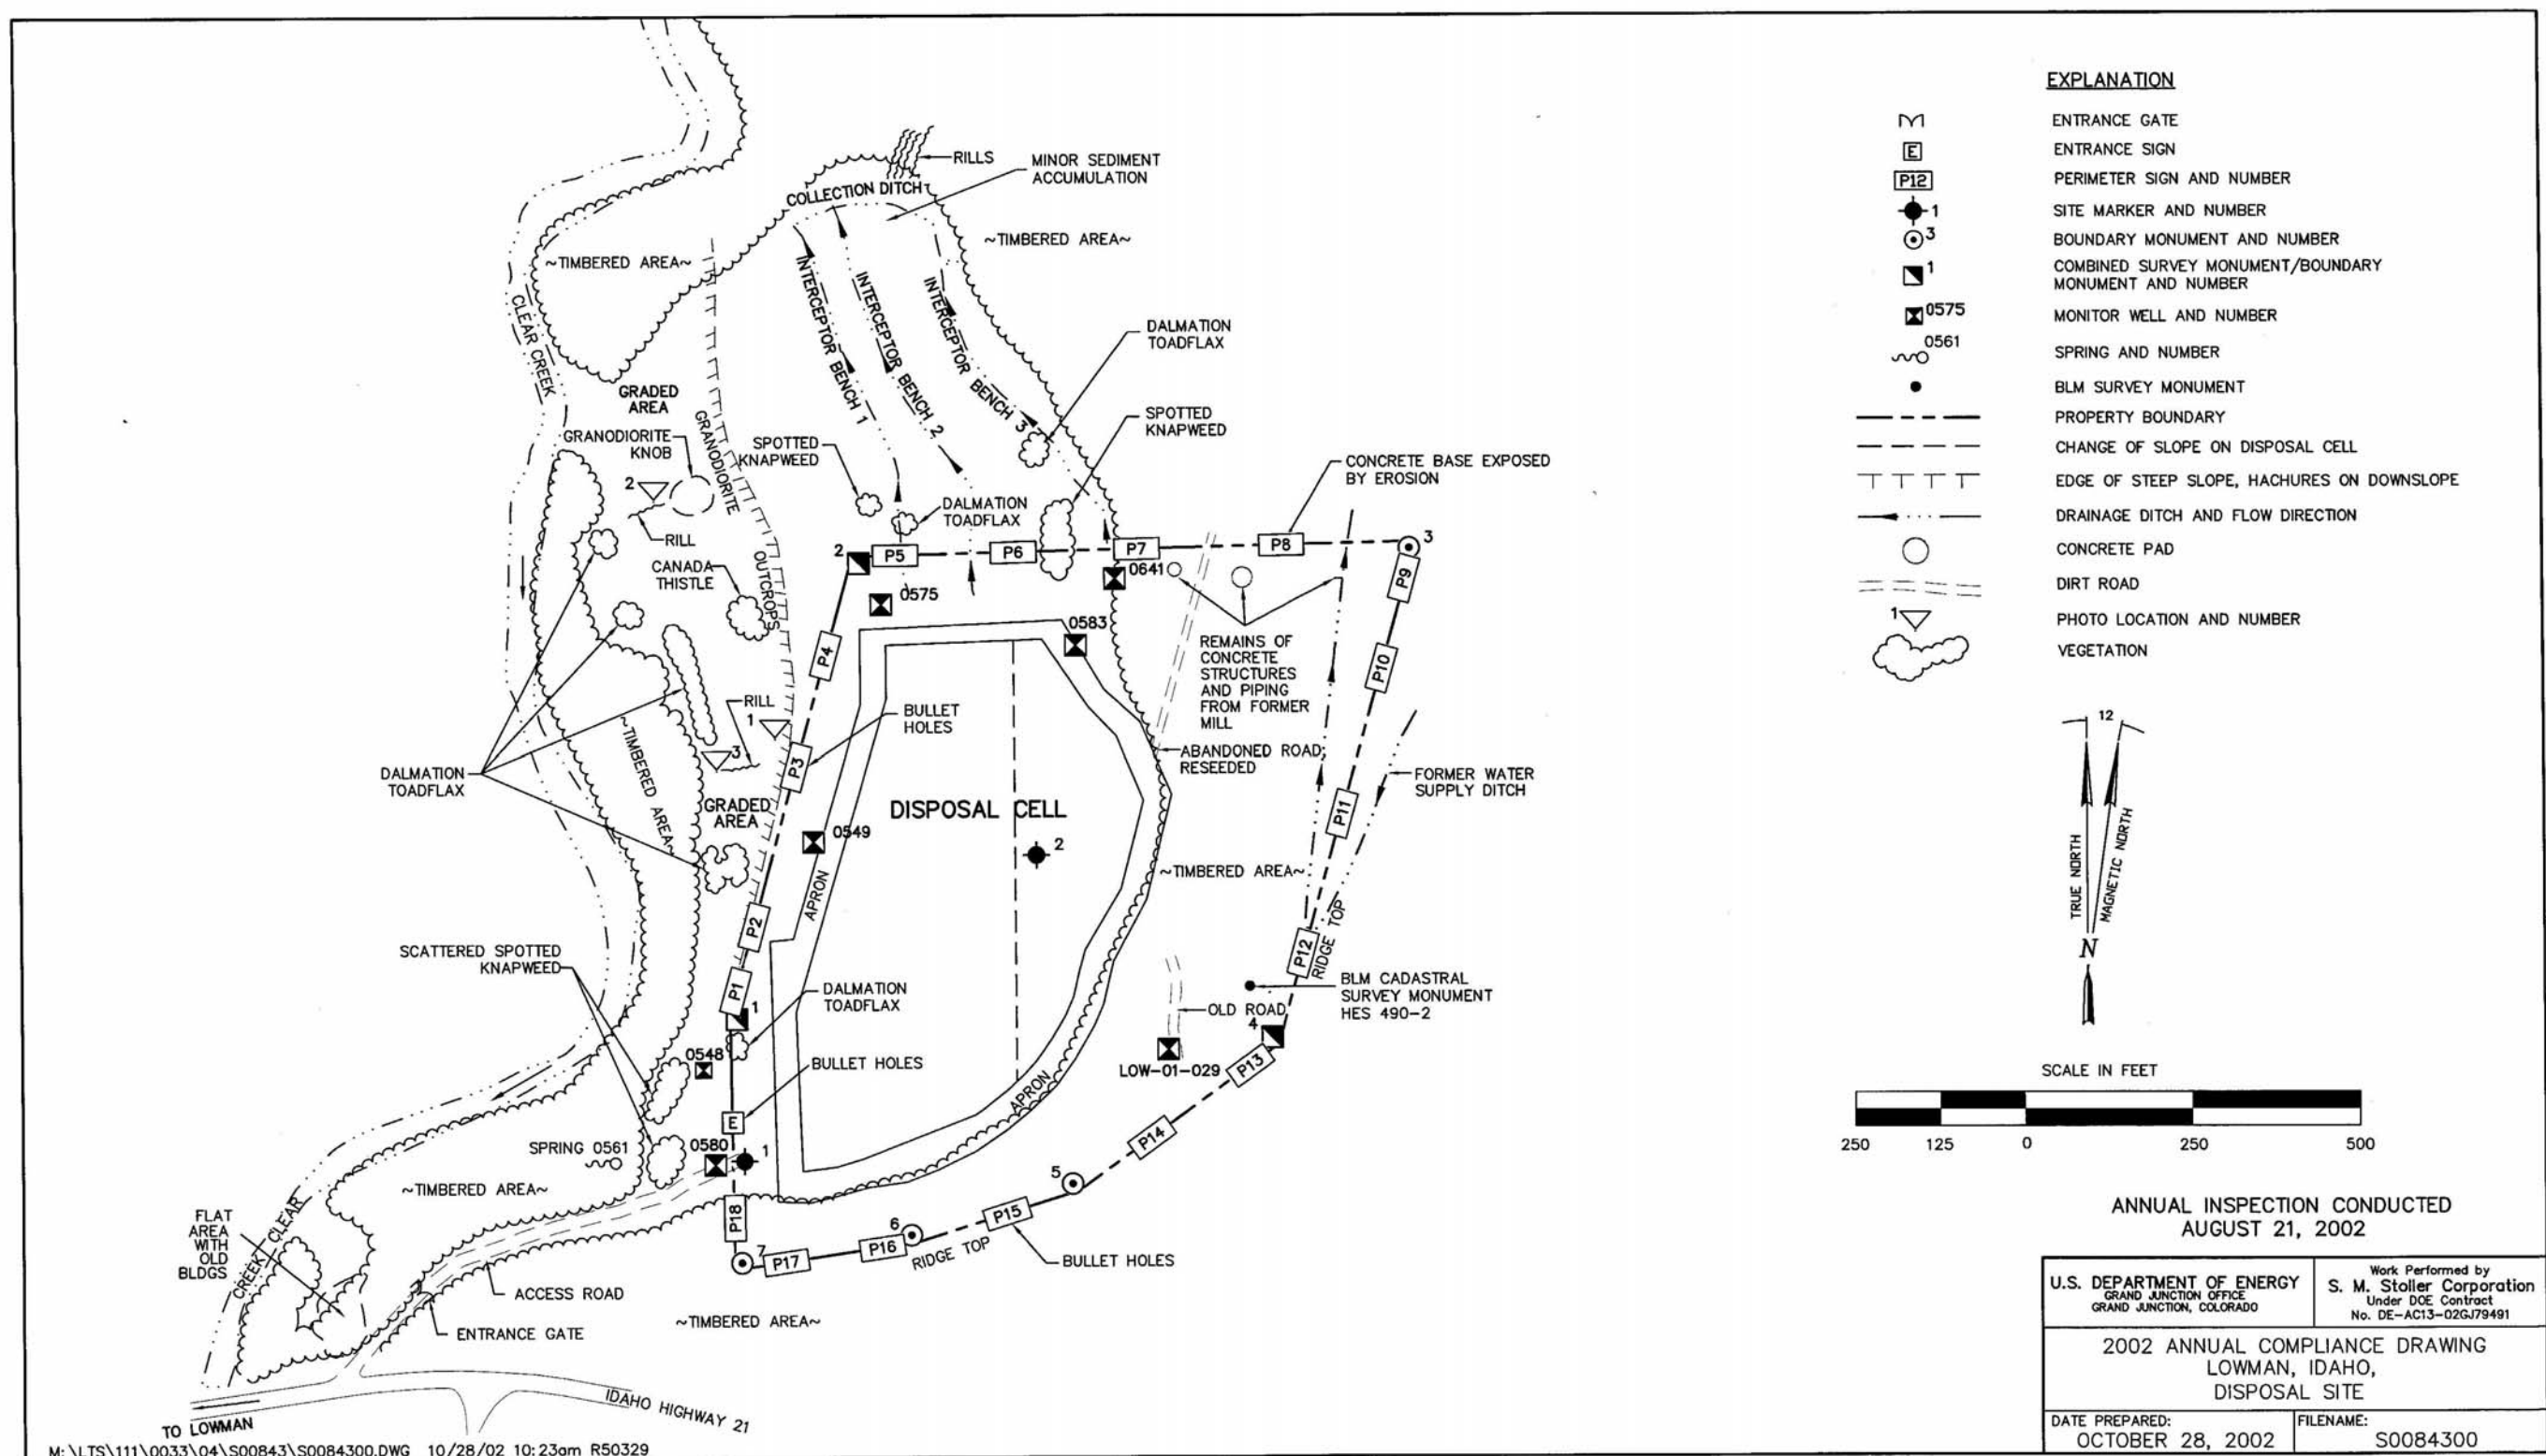
Figure 10-1. 2002 Annual Compliance Drawing for the Lowman, Idaho, Disposal Site

The site, northeast of Lowman, Idaho, was inspected on August 21, 2002. Results of the inspection are described below. Features and the photograph locations (PLs) mentioned in this report are shown on Figure 10-1. Numbers in the left margin of this report refer to items summarized in the Executive Summary table.
